**BUILDING CONDITION SURVEY REPORT**

**CONCORDE CLOSE  
HOUNSLOW  
TW3 4DG**

**HOME GROUP**

**DATE: 24<sup>TH</sup> FEBRUARY 2020**

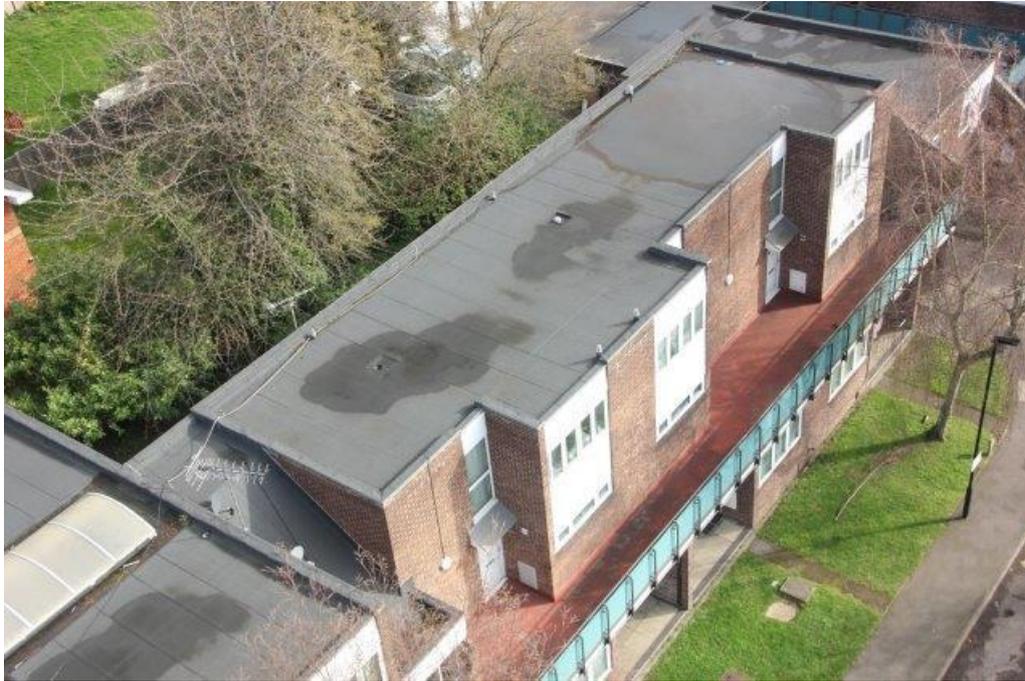
▲ F.01 Severe ponding to main roofs

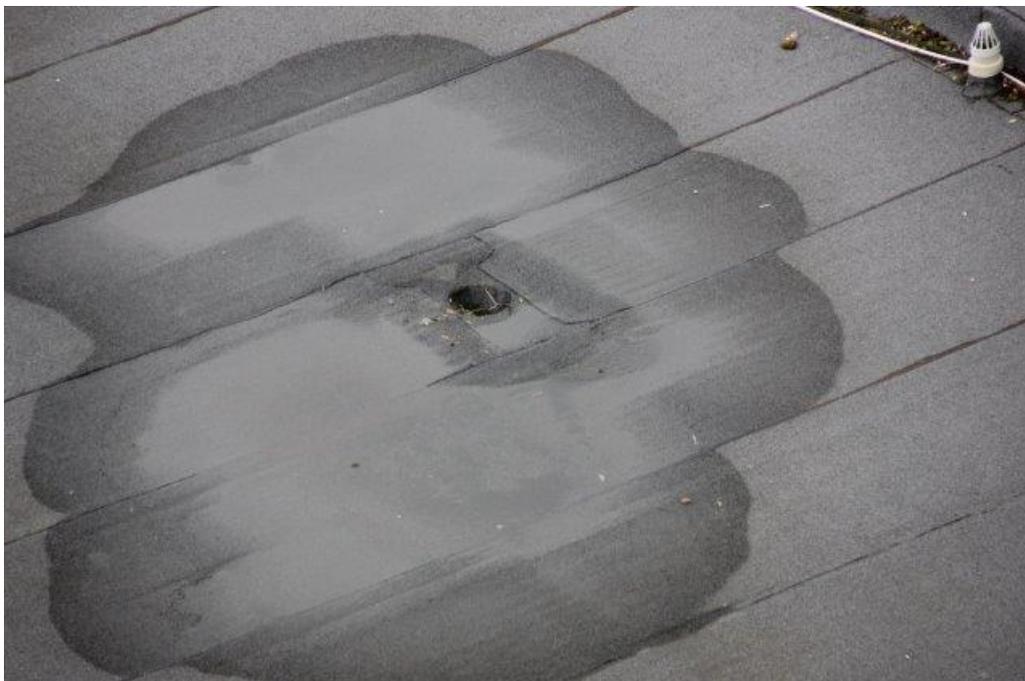
▲ F.02 Poor detailing preventing water from draining into gully

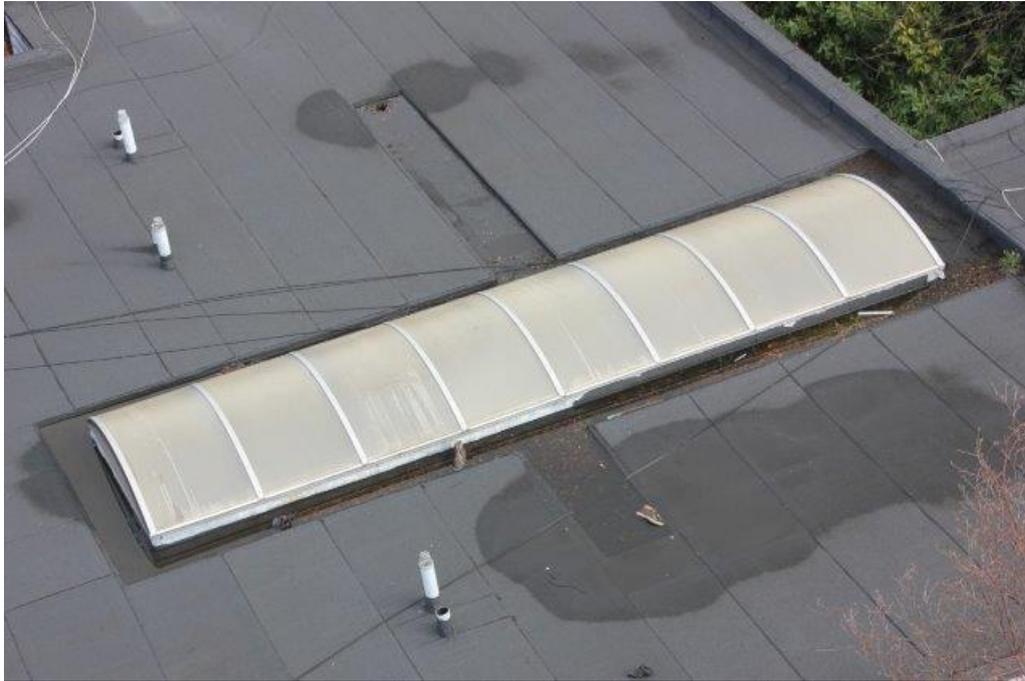
▲ F.03 Gullies and channels completely blocked

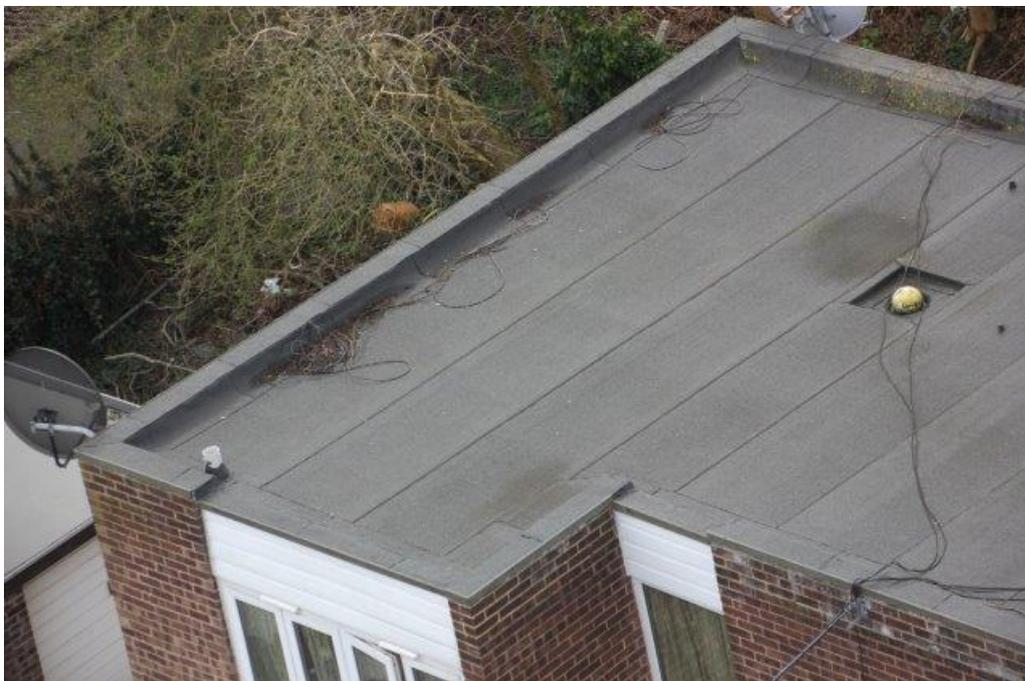
▲ F.04 Blocked gullies and a mess of cabling to all main roofs

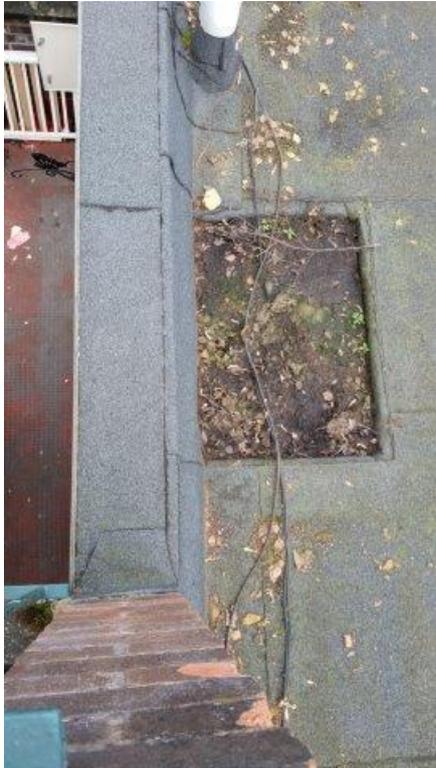
▲ F.05 Blocked gullies

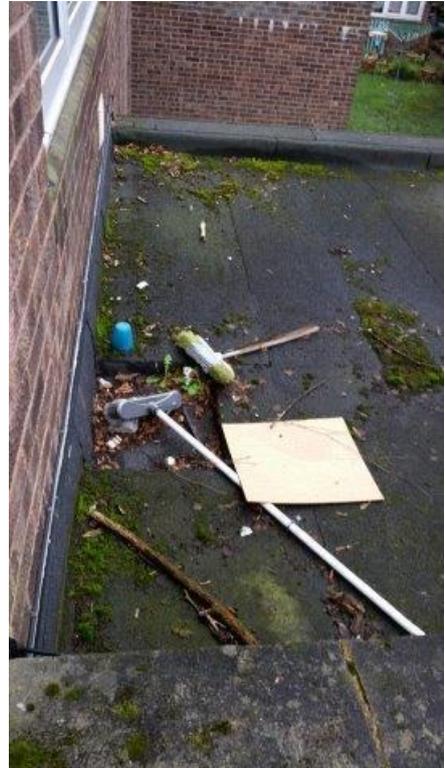
▲ F.06 Low level roofs worse affected

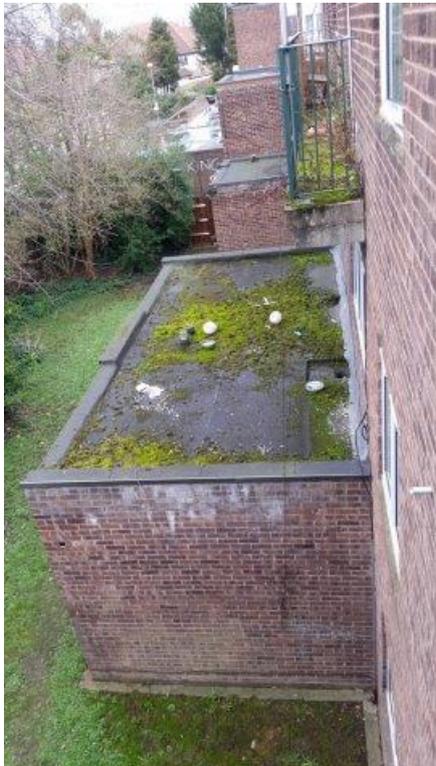
▲ F.07 Vegetation and debris to low roofs

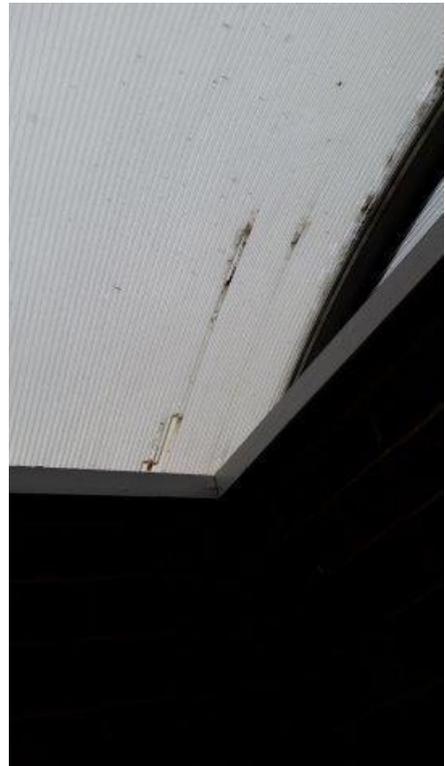
▲ F.08 Rooflight damaged

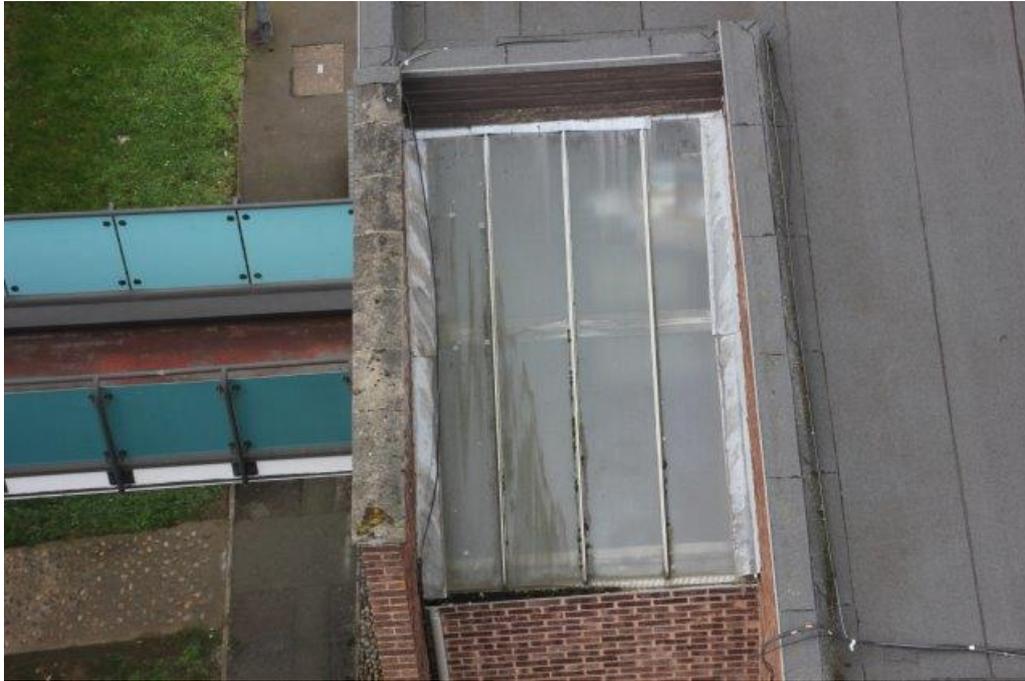
5.1.3.4 Above this area (Block 2) is the roof to the stairwell. This is a mono pitch construction in poly panels set in plastic or aluminium channels [F.09]. The sides and top are sealed with lead flashings that have slipped in places but look to be in reasonable condition. The panels show signs of damage and have moss growing at the junctions with the channels. The rainwater is collected in uPVC guttering and downpipe which is evidently collecting debris and is partially blocked. It is unclear whether there is direct rainwater ingress, but the structure certainly needs closer inspection and maintenance, particularly to the rainwater goods and junctions of the panels.

▲ F.09 Poly roof above stairs to be replaced

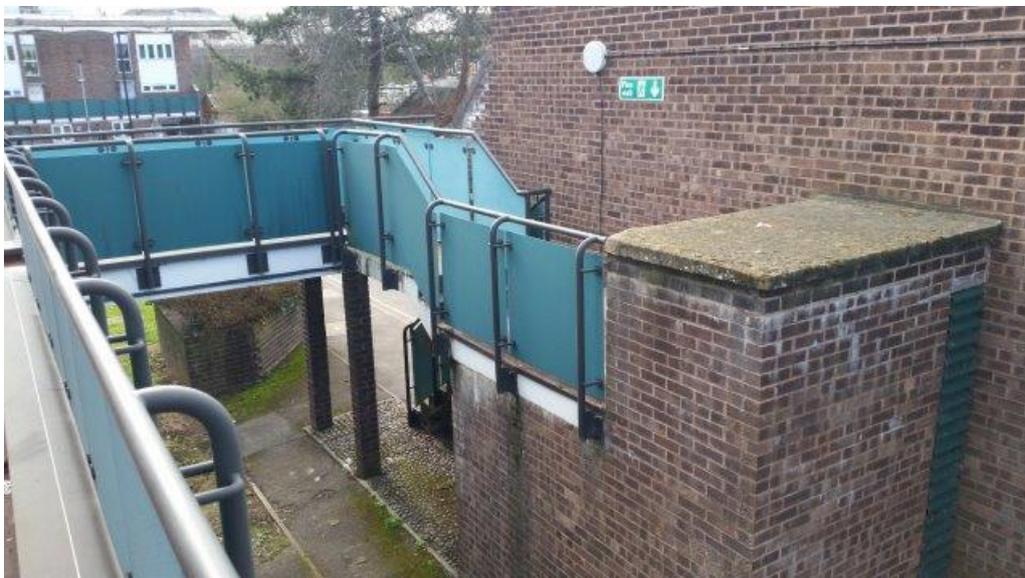
▲ F.10 Bare concrete roof to bin shoot allowing rainwater penetration

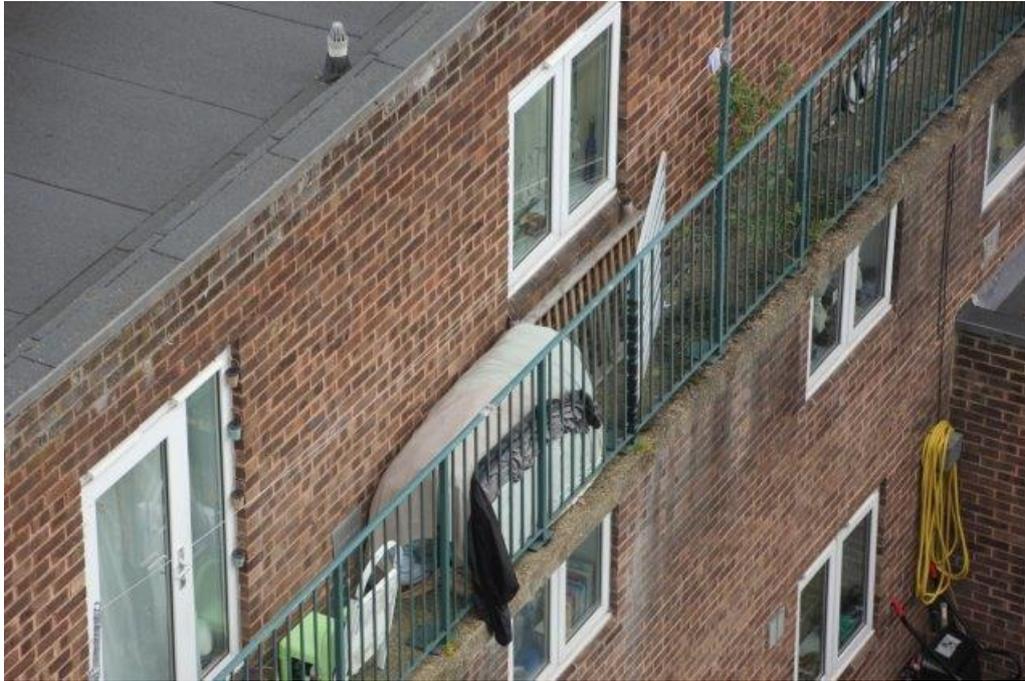
▲ F.11 Balconies saturated and allowing water to penetrate and stain walls

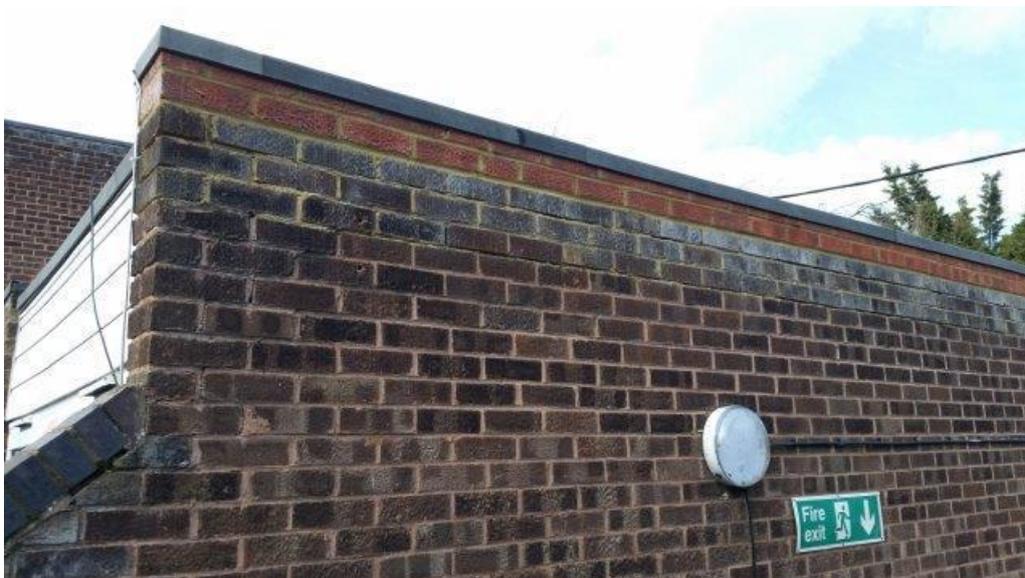
▲ F.12 Some parapets rebuilt due to severity of damage

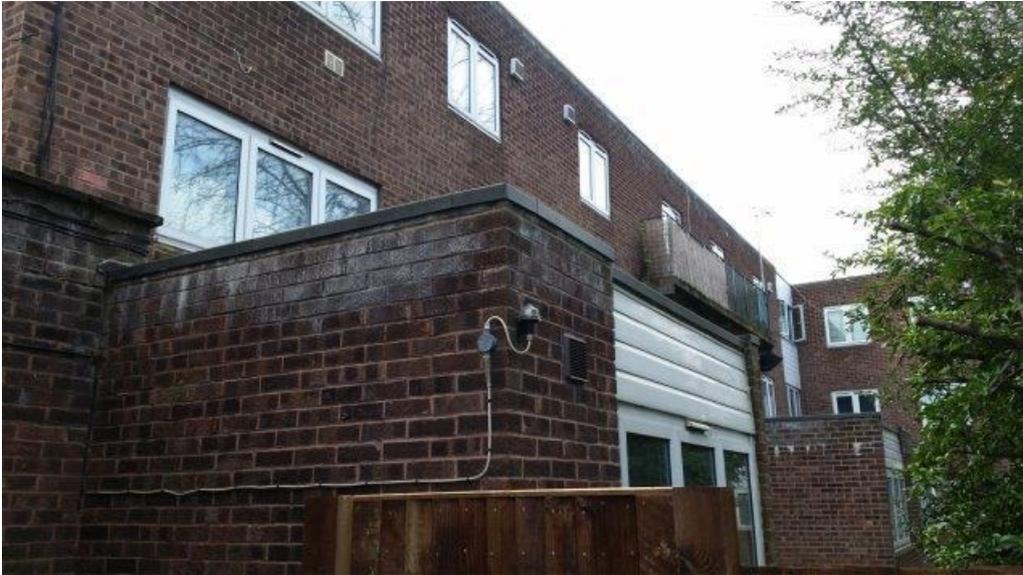
- 5.1.5.4 The most significant damage and defect to the external walls are to the parapets. All parapets to all blocks, and at every height, show evidence of significant defect [F.13]. Many areas have been cleaned up and repointed and some have even been rebuilt [F.12]. However, these remedial works have not resolved the defects and all areas suffer from significant freeze-thaw action, delaminating and spalling of brickwork, mortar joints have “popped”, and there is significant efflorescence staining to the faces [F.14]. It is evident that water is freely penetrating the brickwork and mortar joints and is most likely entering the cavity too.

▲ F.13 Parapets in poor condition

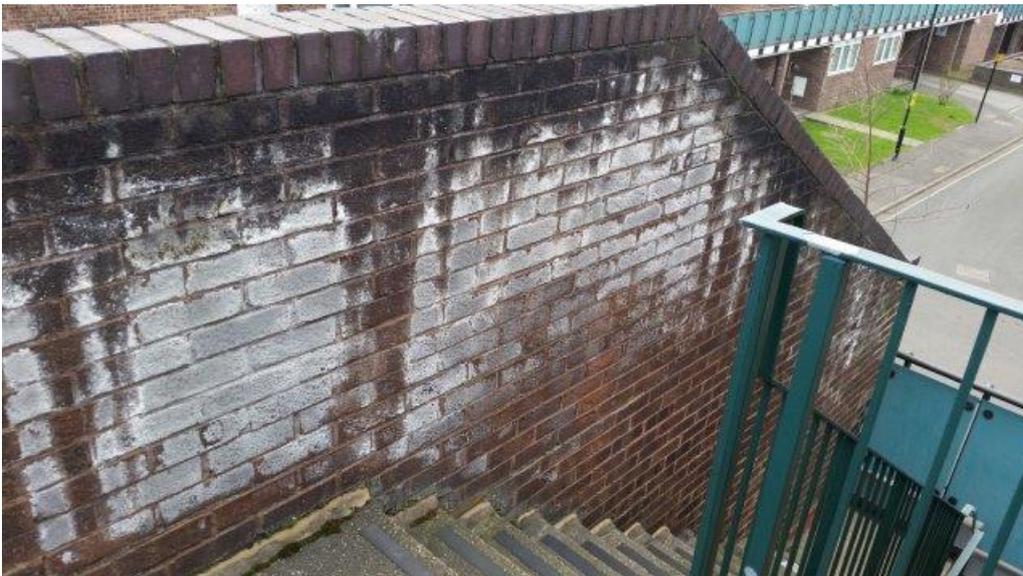
▲ F.14 Exposed areas worse affected. Severe efflorescence shown here.

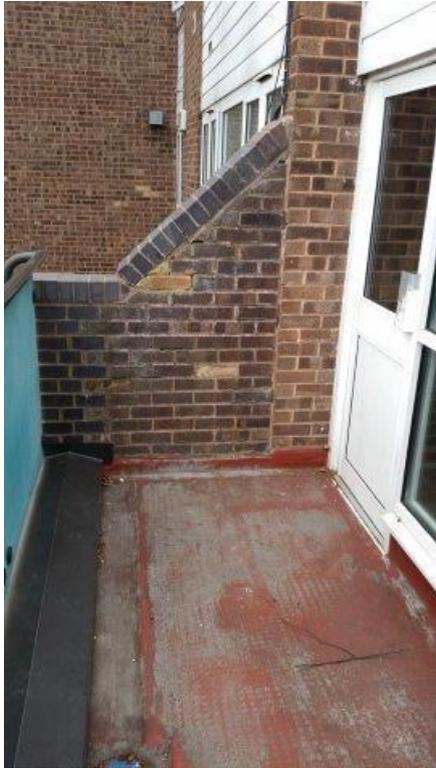
▲ F.15 Parapet dangerously loose

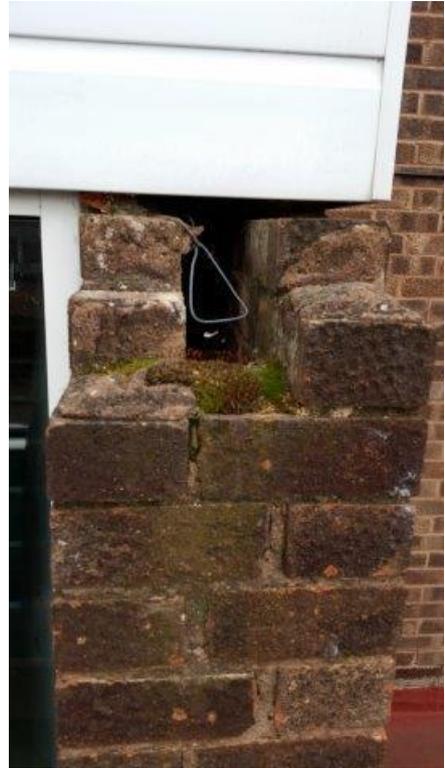
- 5.1.5.6 To the other side of the stairway door opening, the brick coping is missing completely, exposing the cavity to the elements [F.16]. This looks to have been this way for some time as the exposed mortar joints look weathered and have moss growing to the surface. This should also be addressed immediately.

▲ F.16 Coping missing exposing cavity

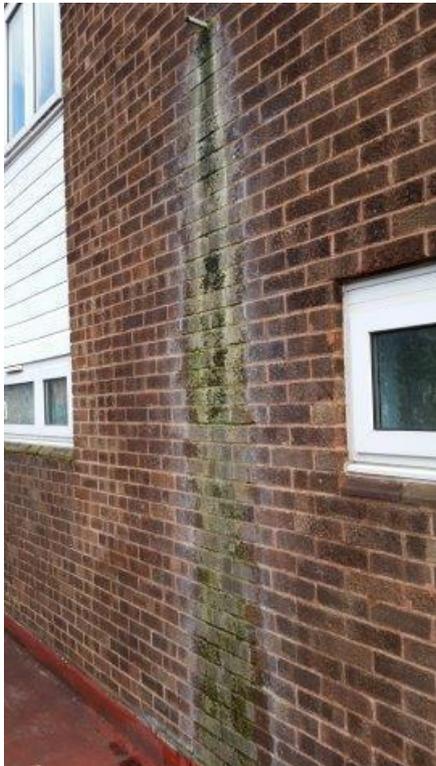
- 5.1.5.11 There are further areas of ad hoc defect and damage such as paint staining and leaky condensate pipes to Block 2 [F.17], areas where signage has previously been removed but the adhesive has been left (to Blocks 1 and 3), and aesthetic inconsistencies where areas of cleaned, repointed brickwork directly adjoins weathered and dirty areas.

▲ F.17 Condensate pipe staining

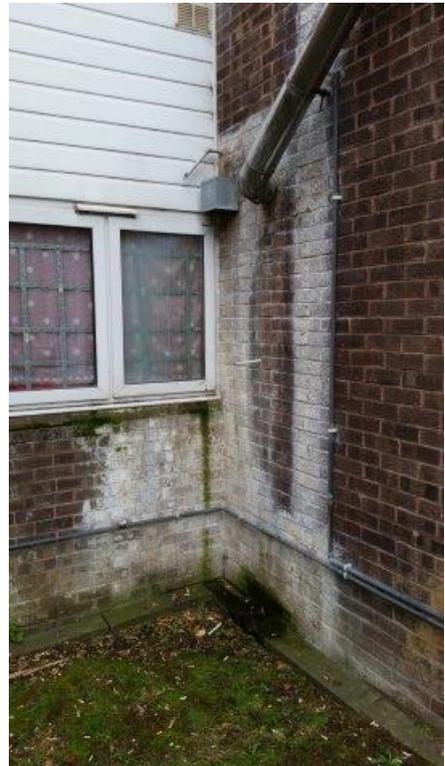
▲ F.18 Severe staining to Block 1

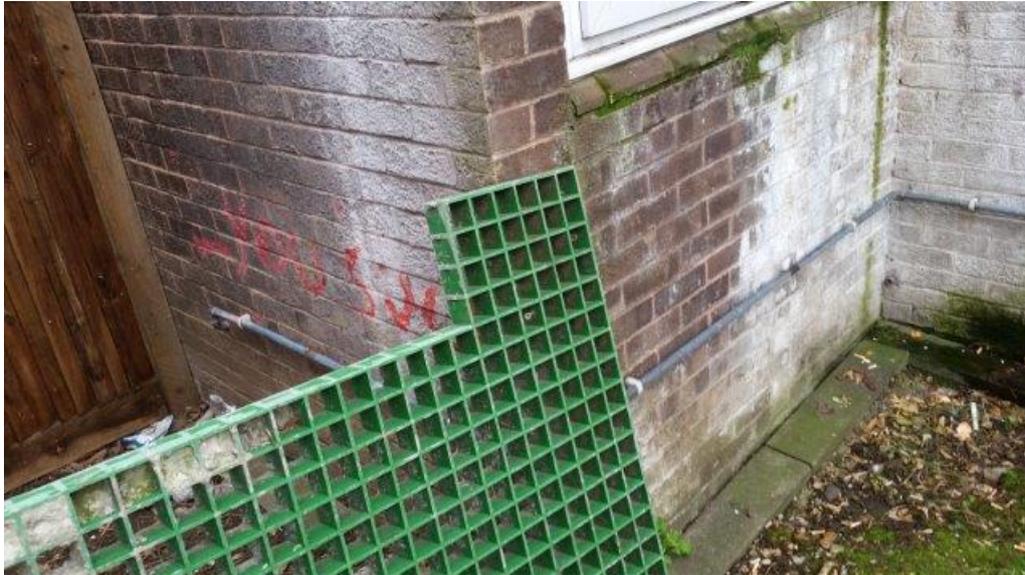
▲ F.19 Graffiti to Block 1

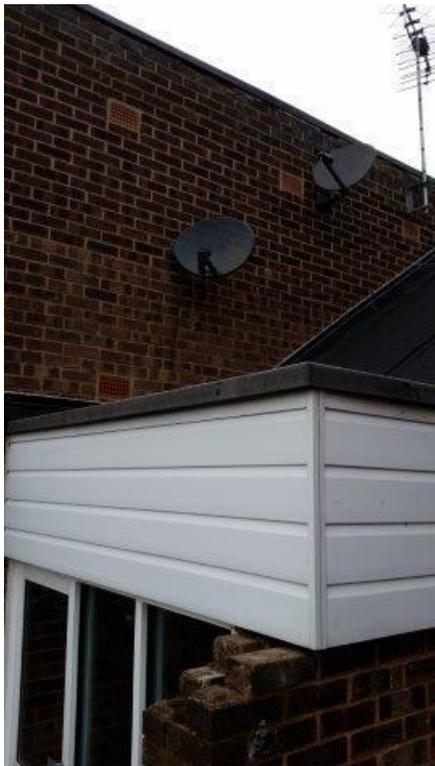
- 5.1.5.7 It was noted that several flats have had air bricks installed, such as a flat in Block 1 [F.20]. No access was achieved to this flat, or the others with air bricks, however, if they have HRVS (heat recovery ventilation systems) as the other flats, then the air bricks should not be installed as the two ventilation types are incompatible.

▲ F.20 Air bricks to flat with HRVS

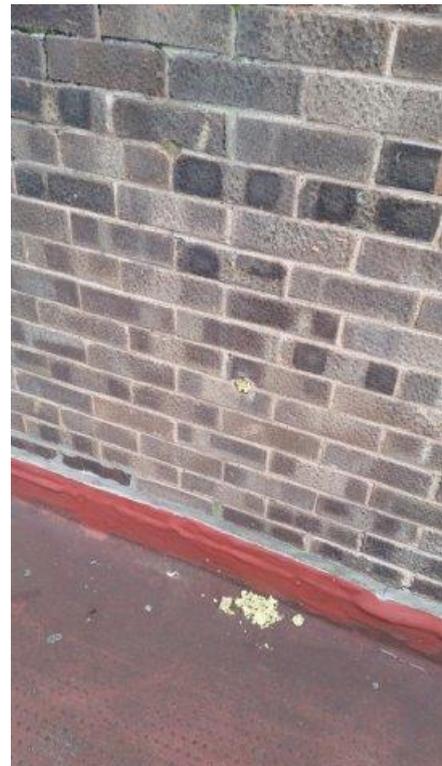
- 5.1.5.8 There is a small hole to an external wall on the Block 1 1<sup>st</sup> floor walkway [F.21]. This hole was previously drilled for the installation of the CWI system and then filled with mortar. However, the mortar is missing, and insulation is freely pouring out of the hole. This should be filled with repair mortar again (along with all other holes to the blocks).

▲ F.21 Cavity wall insulation coming from wall where mortar has "popped"

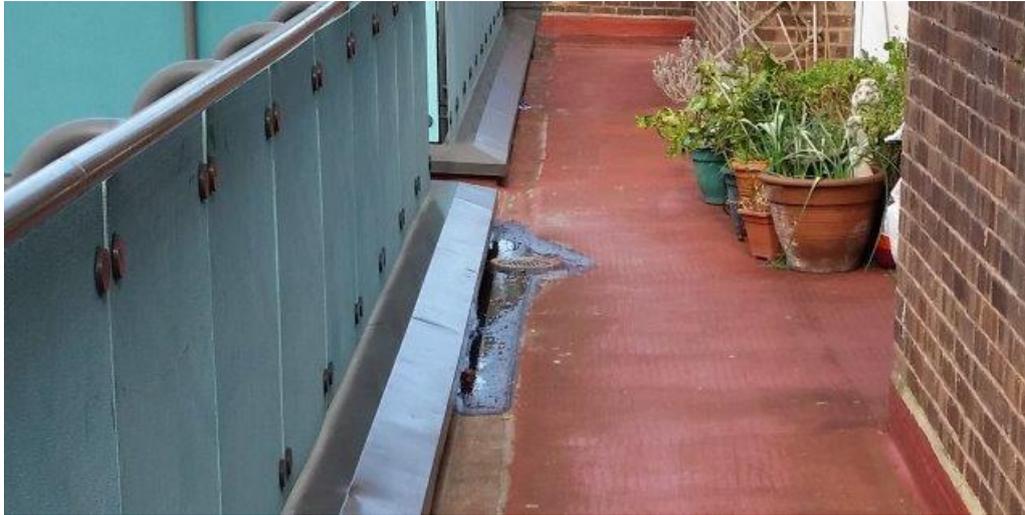
▲ F.22 Poor detailing to walkway gully not allowing water to drain

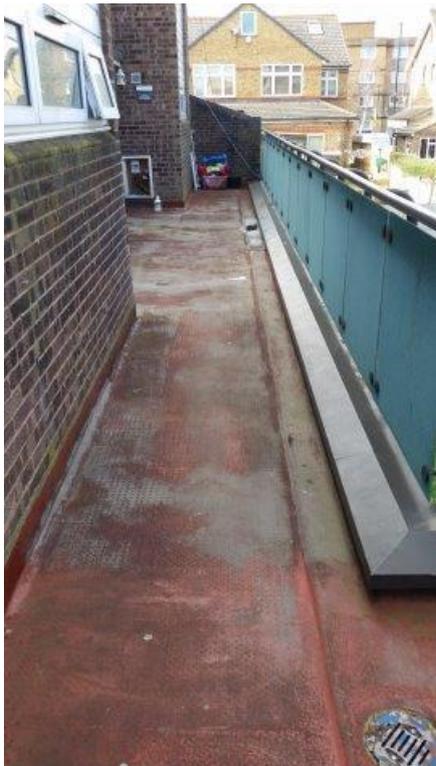
▲ F.23 Walkway covering discolouring and losing tactile texture

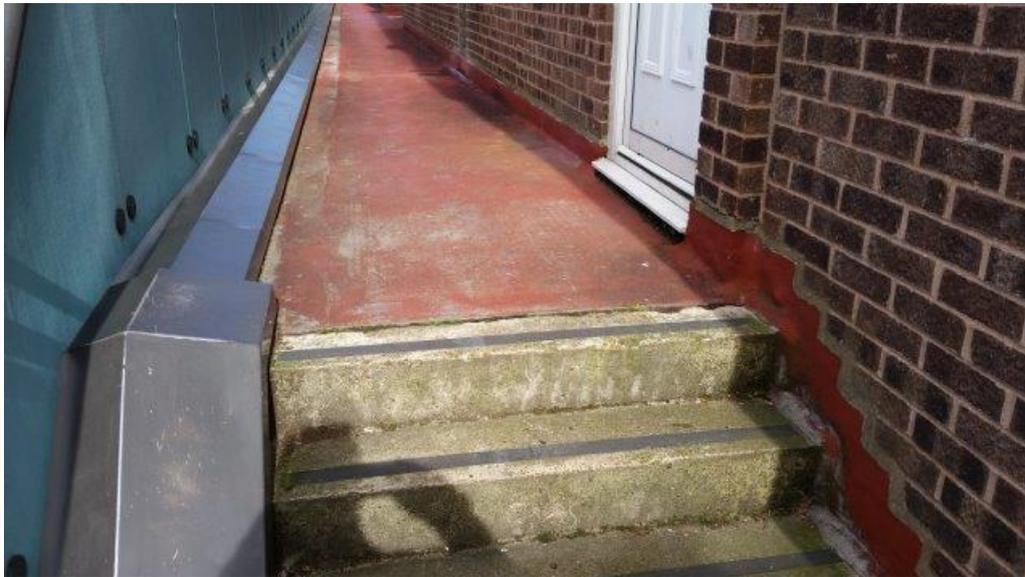
▲ F.24 Mortar fillet cracked

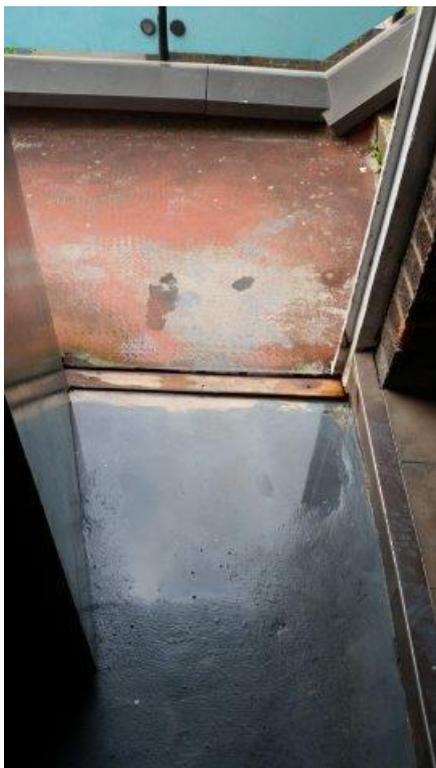
▲ F.25 Inadequate falls and poor detailing allowing rainwater to pond dangerously on landing above stairs.

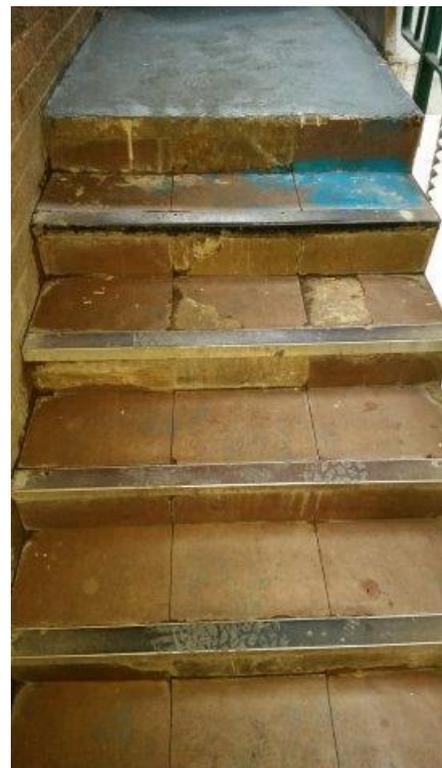
▲ F.26 Flooring tiles in very poor condition

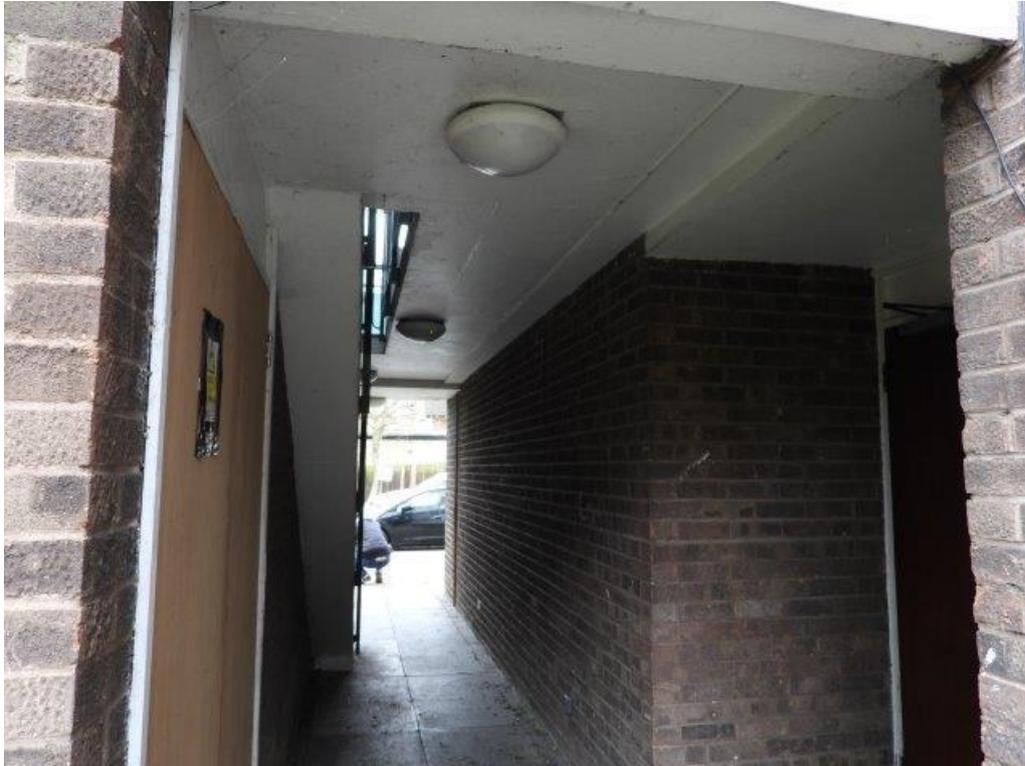
▲ F.27 Stair soffits and ceilings requiring decorations

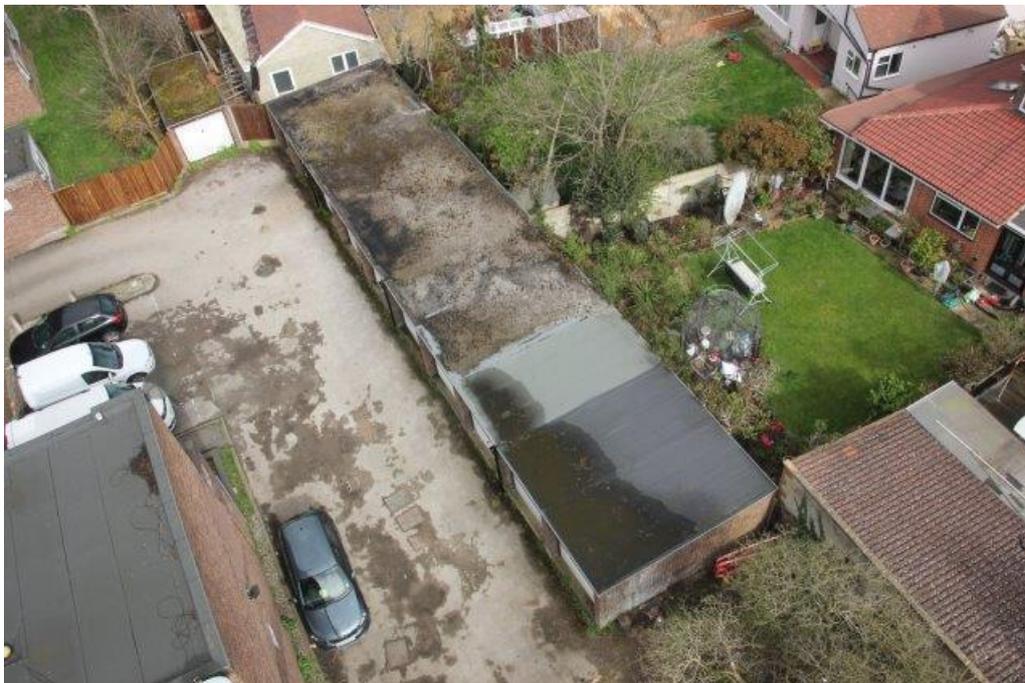
▲ F.28 Garage block roofs saturated, not draining and allowing vegetation to grow

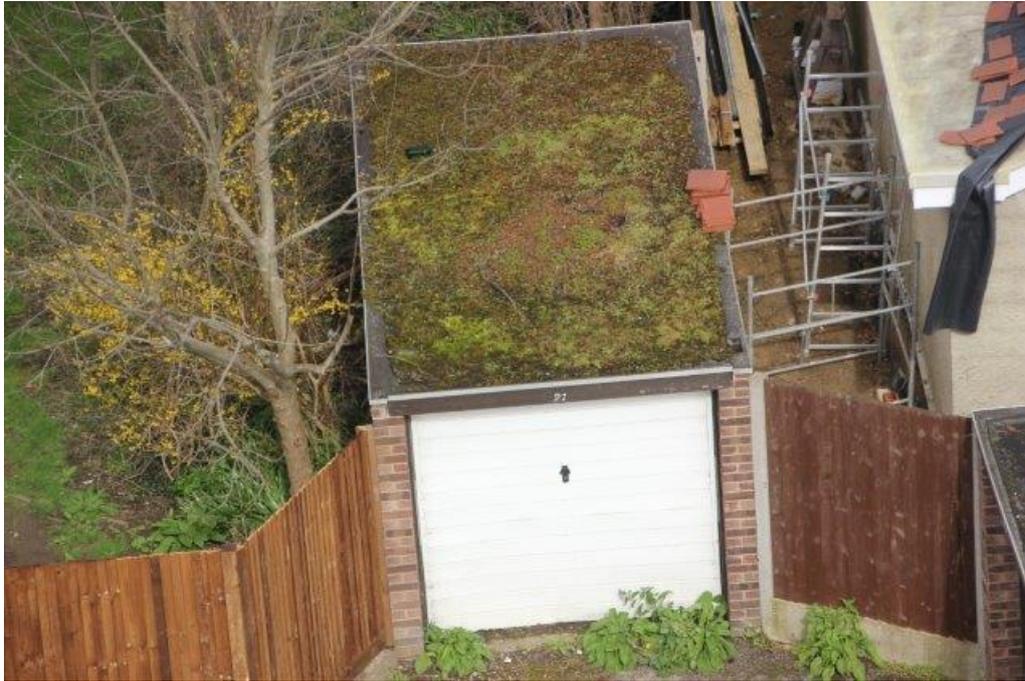
▲ F.29 Garage block roofs saturated, not draining and allowing vegetation to grow

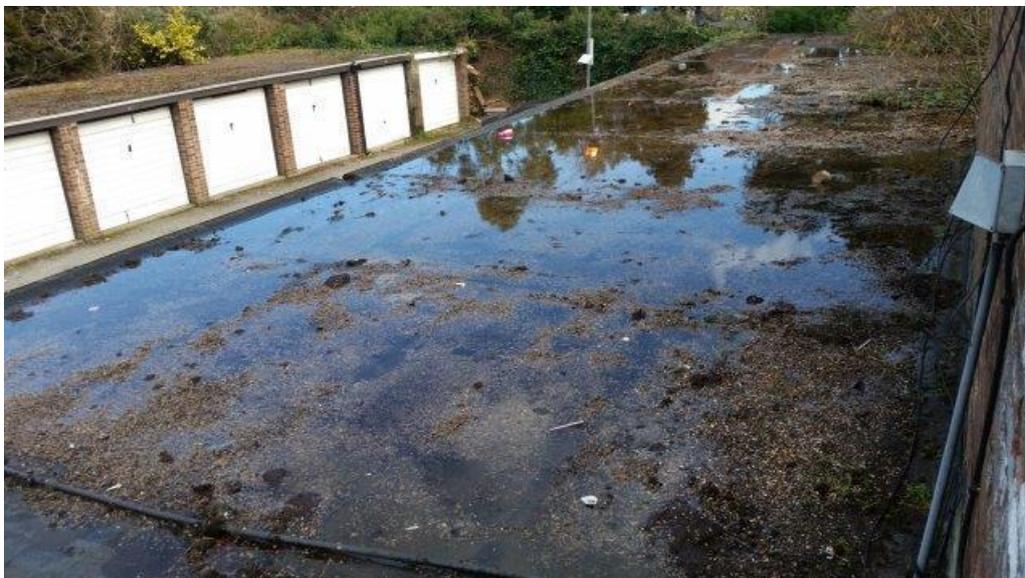
▲ F.30 Garage block roofs saturated, not draining and allowing vegetation to grow

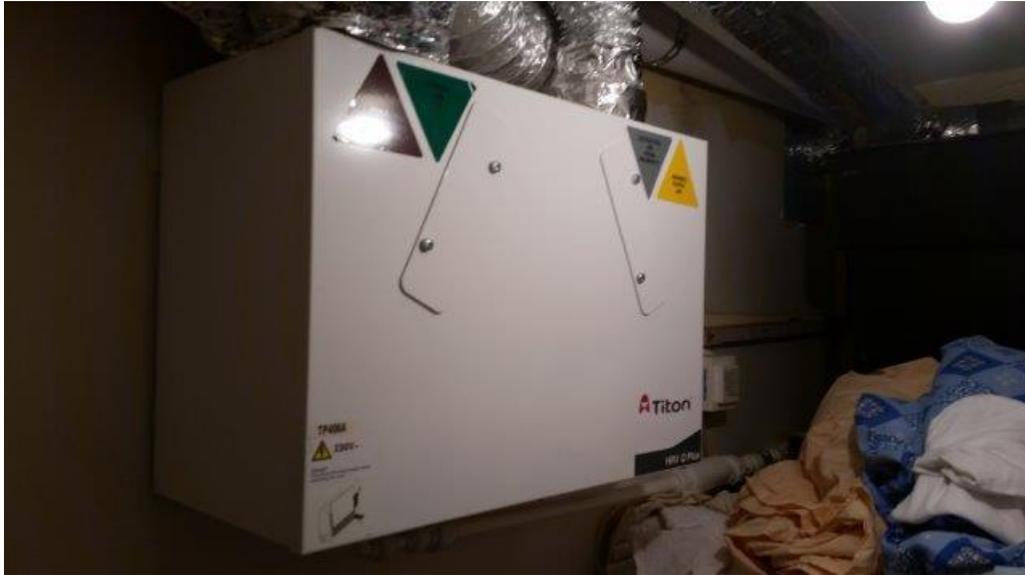
▲ F.31 HRV systems poor performance

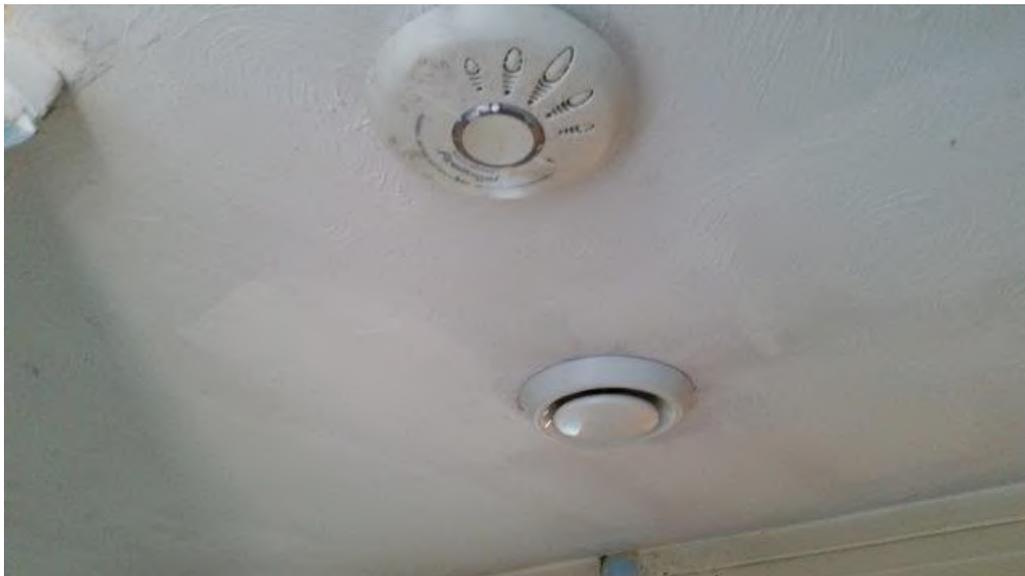
▲ F.32 Redundant fittings left

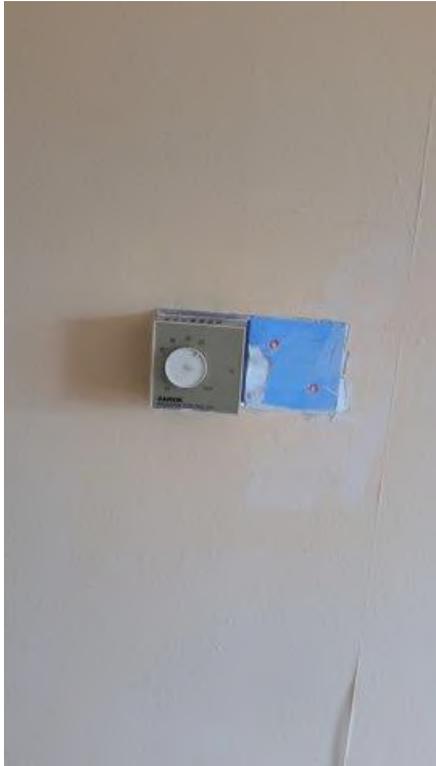
▲ F.33 Redundant fittings left

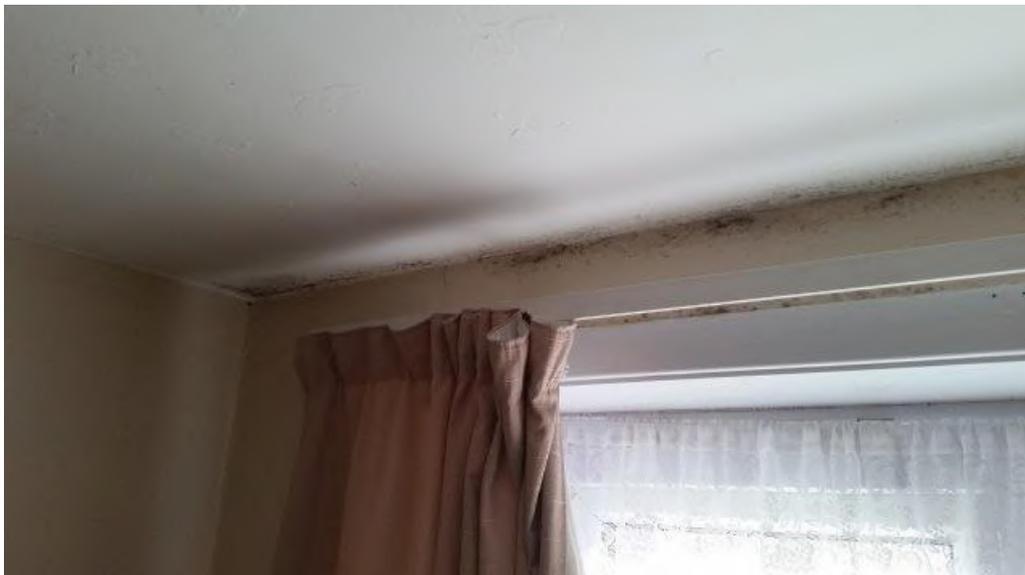
▲ F.34 Condensation prevalent throughout

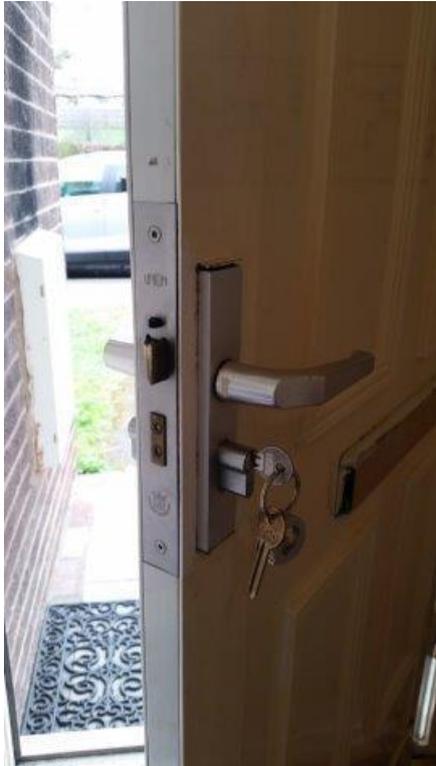
▲ F.35 Problems with doors and locks common

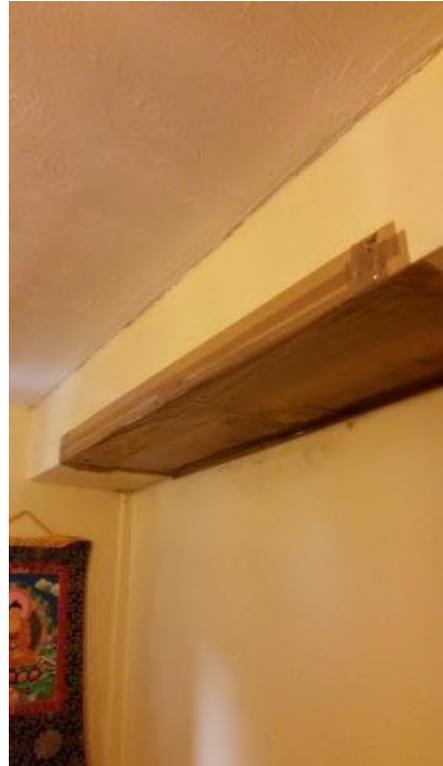
▲ F.36 Water ingress through ventilation ducting

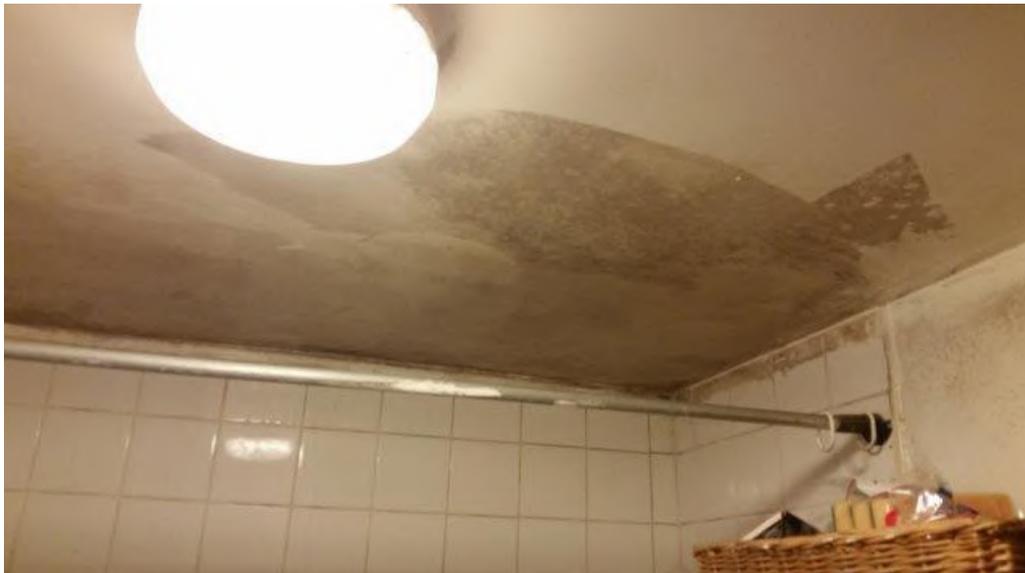
▲ F.37 Severe condensation to many bathrooms

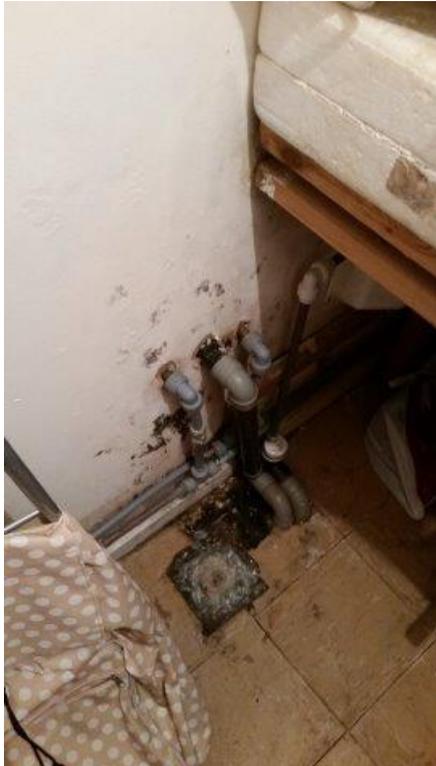
▲ F.38 Leaking pipework

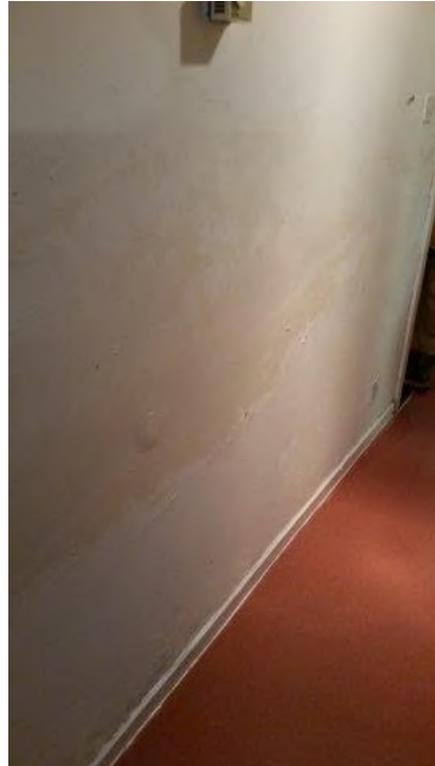
▲ F.39 Internal walls saturated throughout with no obvious cause

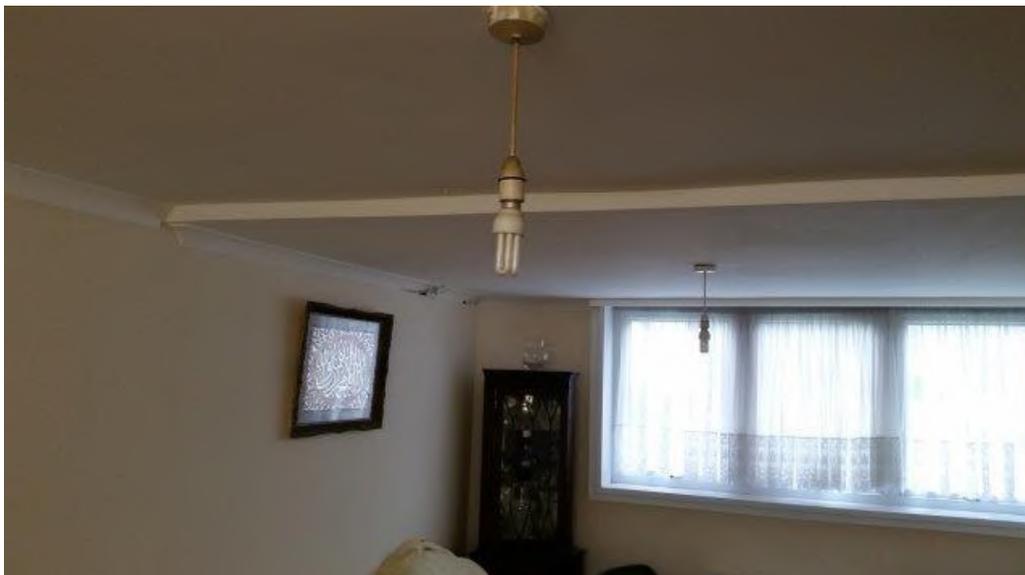
▲ F.40 Bulkhead installed to cover over problems with walkways above

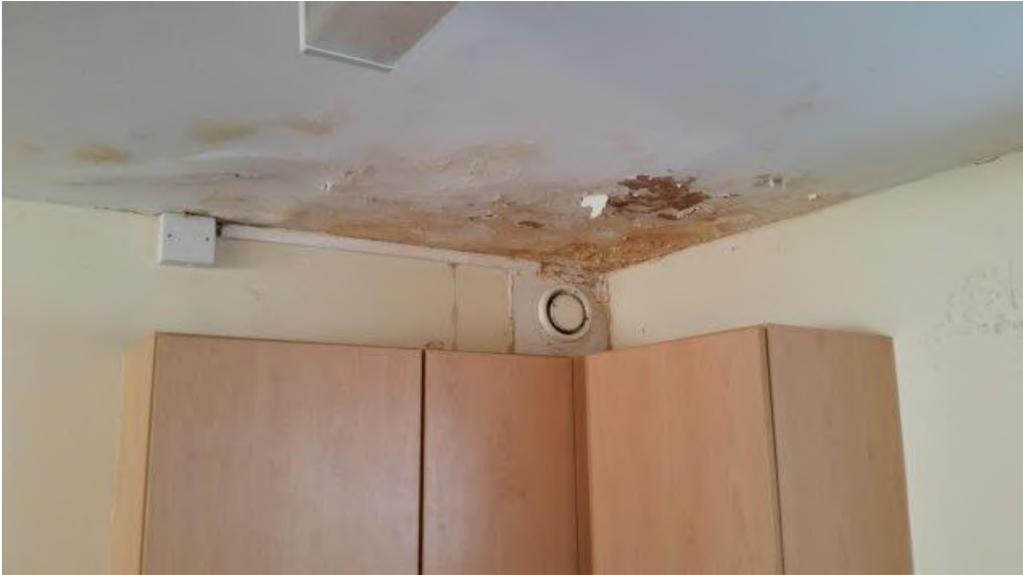
▲ F.41 Void Flat in very poor condition

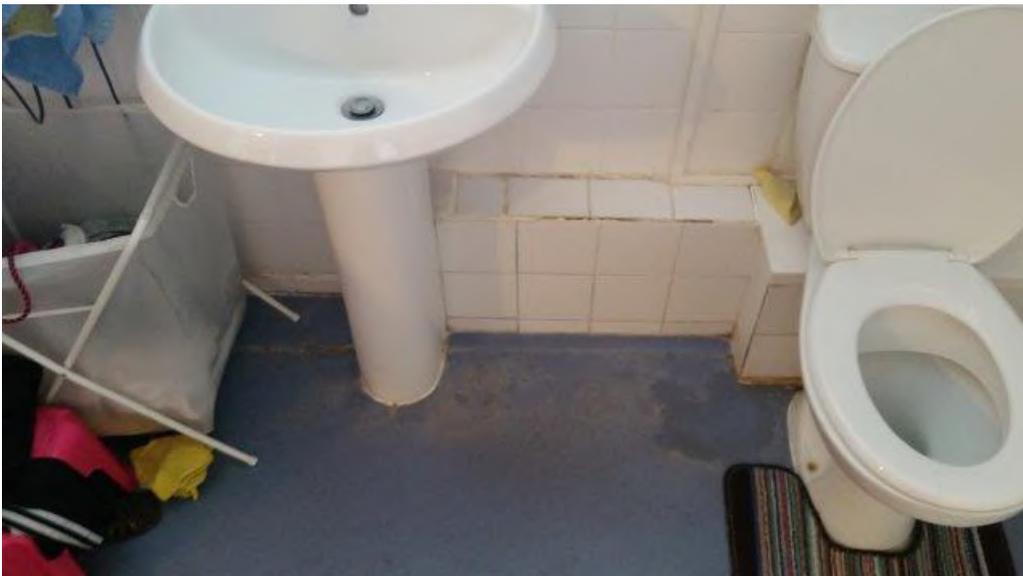
▲ F.42 Bathroom leaks and condensation

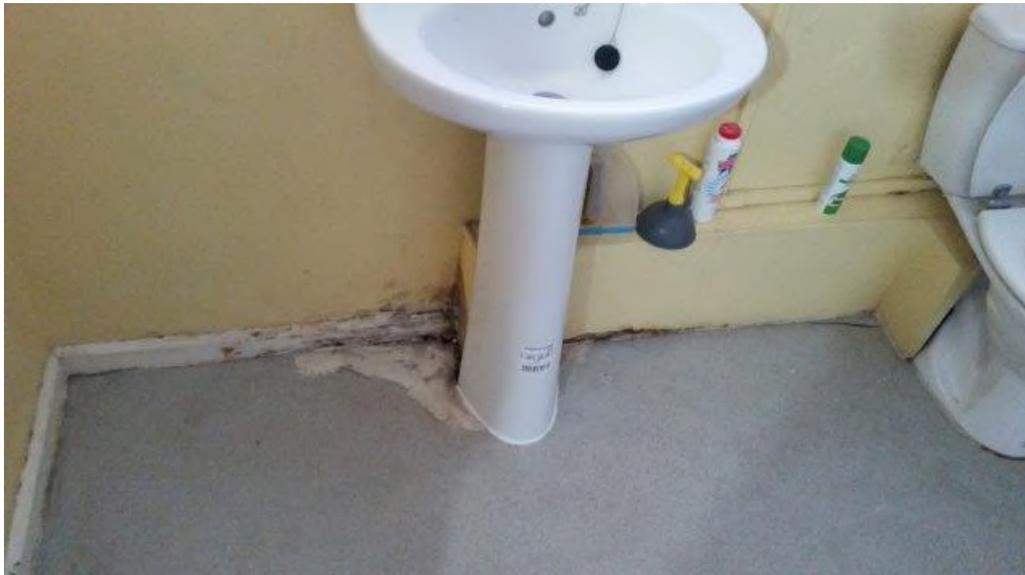
▲ F.43 More bathroom leaks and condensation
