**BUILDING CONDITION SURVEY REPORT**

**CONCORDE CLOSE  
HOUNSLOW  
TW3 4DG**

**HOME GROUP**

**DATE: 24<sup>TH</sup> FEBRUARY 2020**

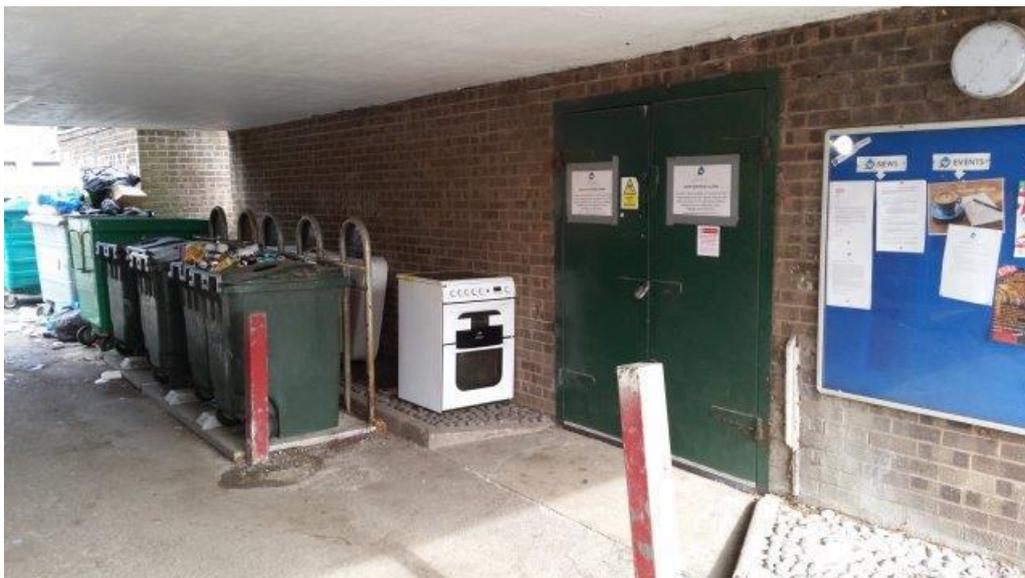
▲ F.44 Fire risk from furniture dumped under overhang soffit

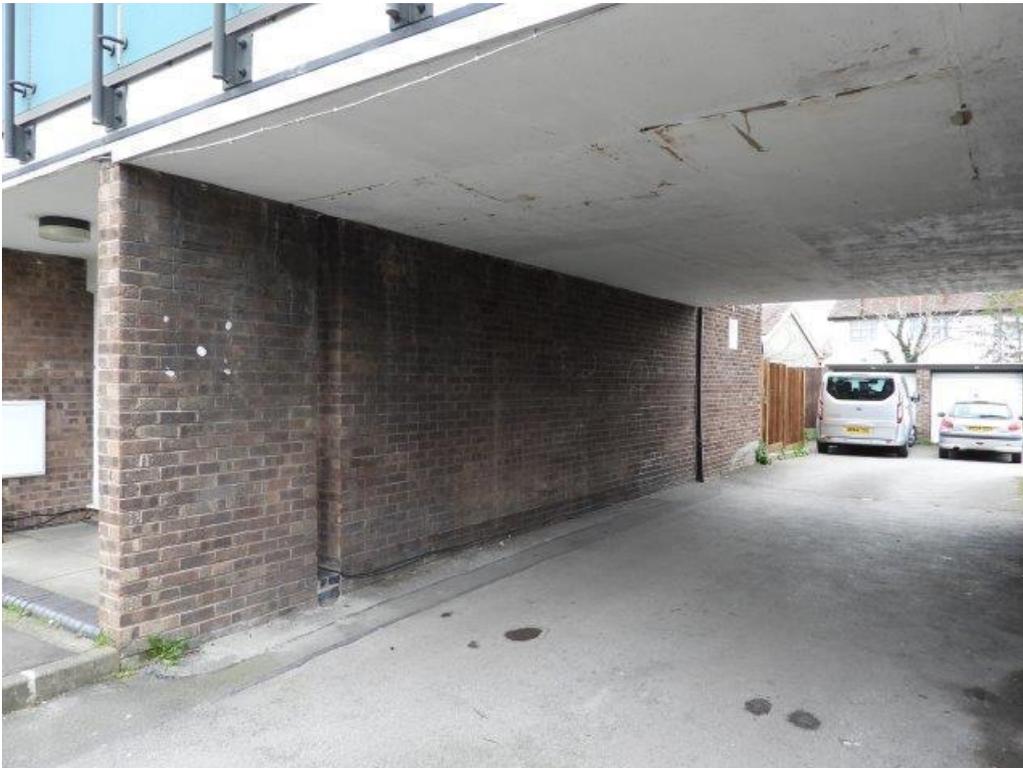
▲ F.45 Fire risk as undercroft ceilings/soffits in poor condition and not fire rated

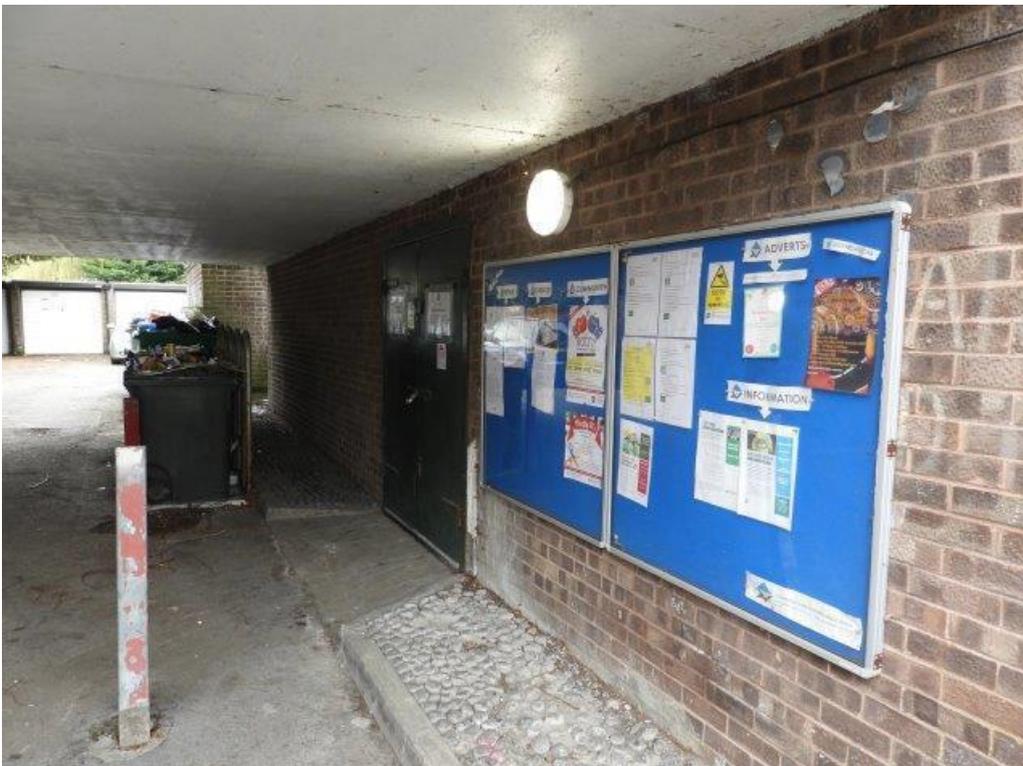
▲ F.46 Noticeboard showing confusing and incorrect information

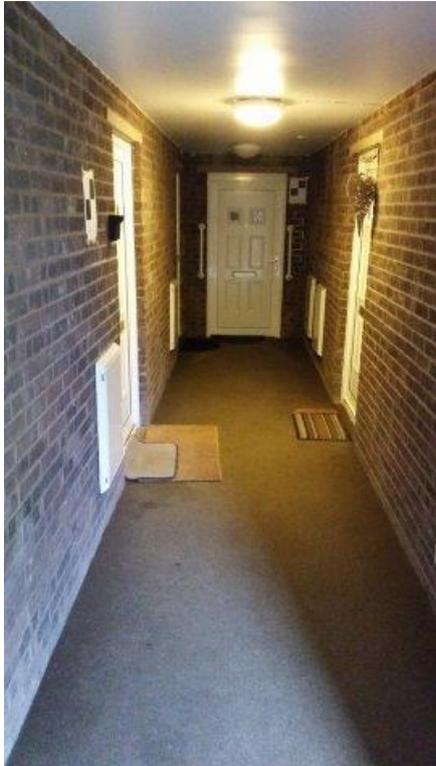
▲ F.47 Non fire doors used internally

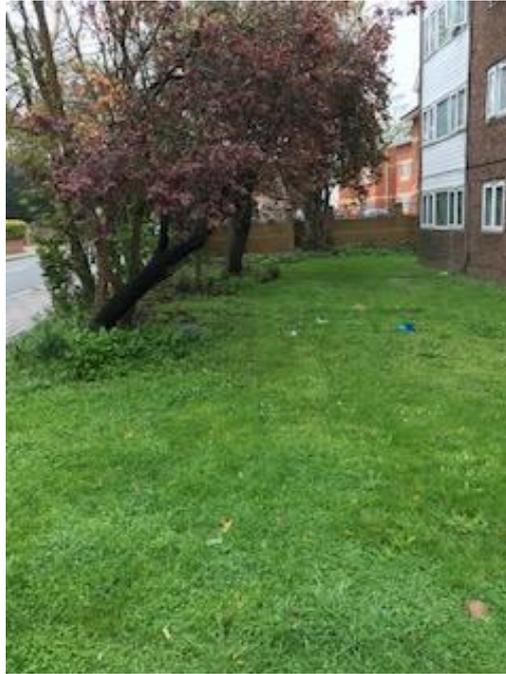
The grass amenity space at the frontage is open with no defensible space or semi -private designation and access can be gained directly off the street. Whilst we were there we saw evidence of drug paraphernalia and garbage strewn in the planting on your property. Our recommendation would be to have this area cleaned up and to install a close boarded wooden fence along your front boundary to prevent easy access this would also be easier to manage and safer for residents. The fencing should not be over 1 metre to maintain the natural surveillance from the main road.

Defensible space will mean residents will have a semi-private area that they will be able to take ownership over and this will reduce the chance of non-residents gaining access into this space.

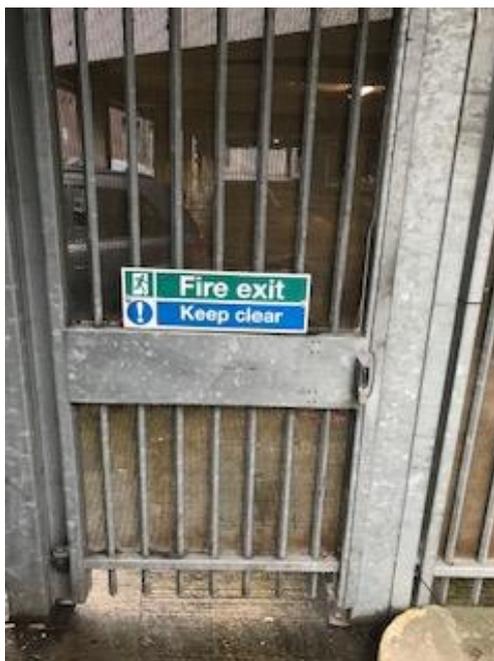
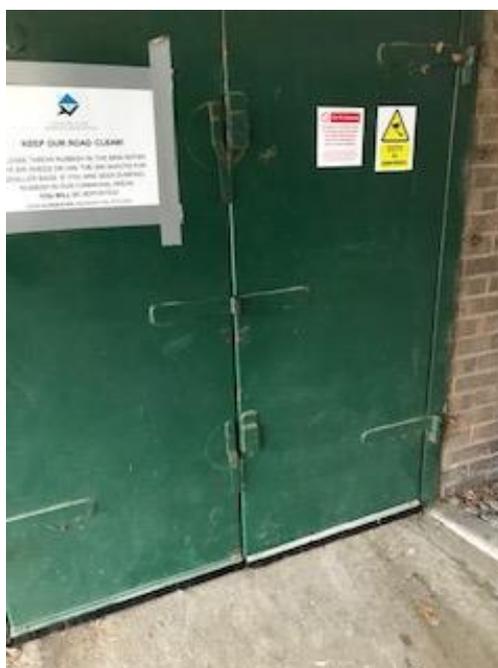
##### **Access to the bin store:**

The bin store has a padlock on each door but these are loose and often left on the ground which means that the bin stores are often left insecure. We suggest a captive padlock system where the padlock is welded with a chain to one on the doors so it can't be removed.

To prevent the padlocks going missing and to help prevent access from non-residents into the bin store.

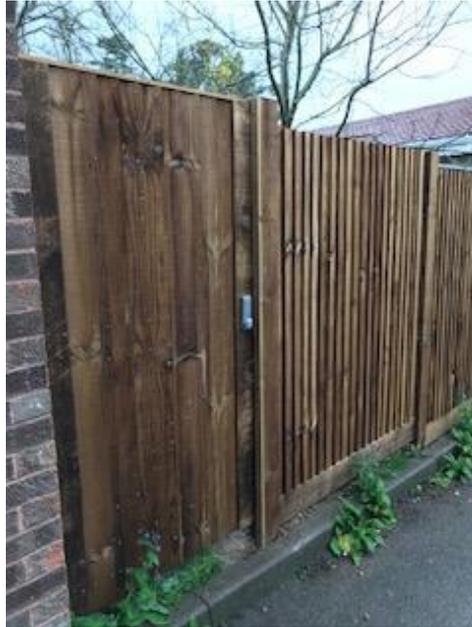
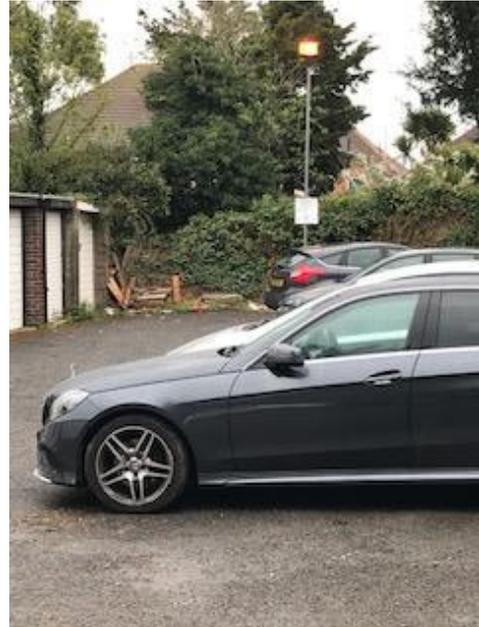
It is clear from the visit that drug dealing is an issue within the small estate and there are several areas out of sight ideal for dealing. By using close boarded fencing with punch code access would be ideal to prevent access and reduce opportunities to commit crime and fly tipping such as the below.
