**BUILDING CONDITION SURVEY REPORT**

**CONCORDE CLOSE  
HOUNSLOW  
TW3 4DG**

**HOME GROUP**

**DATE: 24<sup>TH</sup> FEBRUARY 2020**

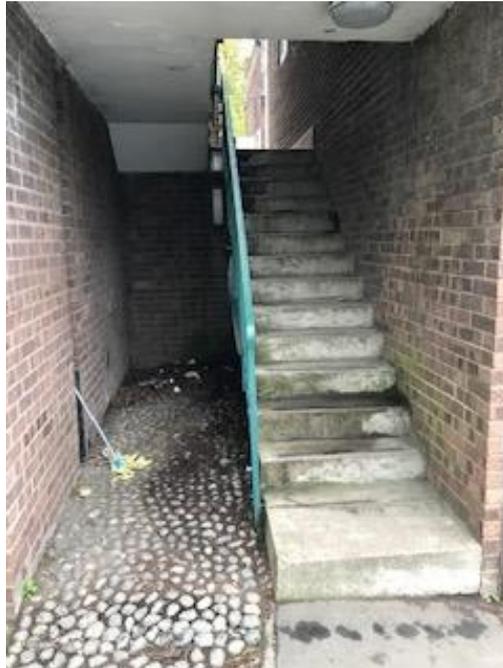
There are several stairwells that allow open and free access into each section of the estate and to the rear of resident's flats these areas are being exploited by individuals for drug use, rough sleeping and other Anti-social behaviour. We recommend that these access points can be meshed off with either a metal mesh with aluminium surround or expanded metal with an integrated entrance gate operated by a punch code lock. We recommend that these are fitted with self-closures and latch shut and have a simple thumb turn for fire escape. We advise that if an open mesh is used then the egress thumb turn is protected so that it cannot be manipulated from outside and it is floor to ceiling so cannot be scaled.

The weakness of the punch coded locks is that residents will have to manage the codes for each entrance as if this is compromised then their security will be vulnerable.

Robust gates with secure entry will allow for lawful access by Contractors, Emergency Services, Staff and residents but will prevent Anti-Social Behaviour and intruders. Below is an example of some options, as you can see the internal thumb turn is protected so cannot be tampered with from the exterior face.

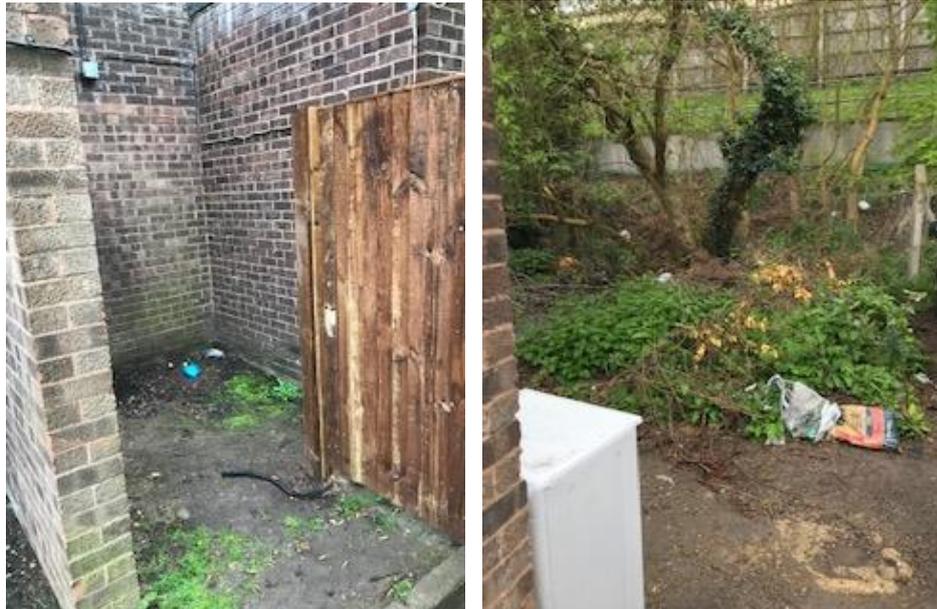
As discussed out on site it would be unreasonable to gate off the undercrofts leading to the rear car parks and garages at the rear. However there are small areas linked to these areas we call iffy spaces which serve no purpose out of sight but are ideal for drug dealing, ASB etc. Close boarded fencing has been implemented in certain areas already but there are some areas which would benefit from them for the time being.

It is clear from the visit that drug dealing is an issue within the small estate and there are several areas out of sight ideal for dealing. By using close boarded fencing with punch code access would be ideal to prevent access and reduce opportunities to commit crime and fly tipping such as the below.
